DRAFT OF REPAIR PROPOSAL

DUVAL BRANCH OF WALNUT CREEK – PAVED TRAIL EROSION REPAIRS

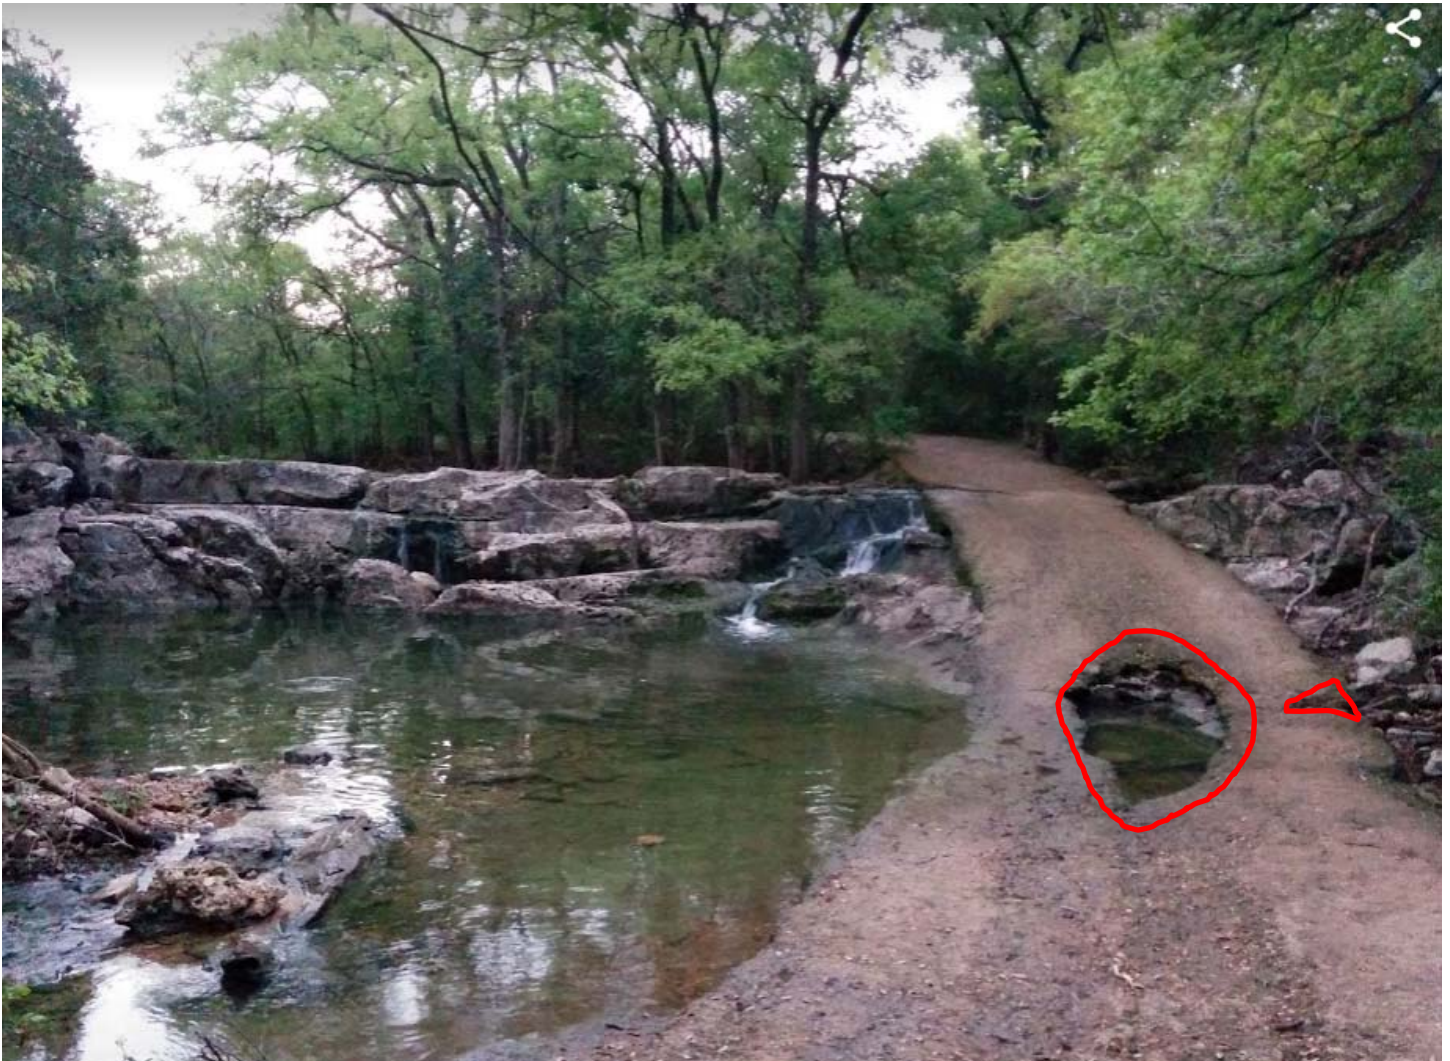
1 – waterfall area – large washout at base of steep trail section. This is the highest priority repair due to 1) safety concerns with trail users (cyclists, runners, kids) accidentally falling into the void and 2) high energy gradient has potential to collapse the trail with chunks of concrete and underlying fill creating scour and sedimentation downstream. Note photo was taken approx. 5 days after significant rainfall.

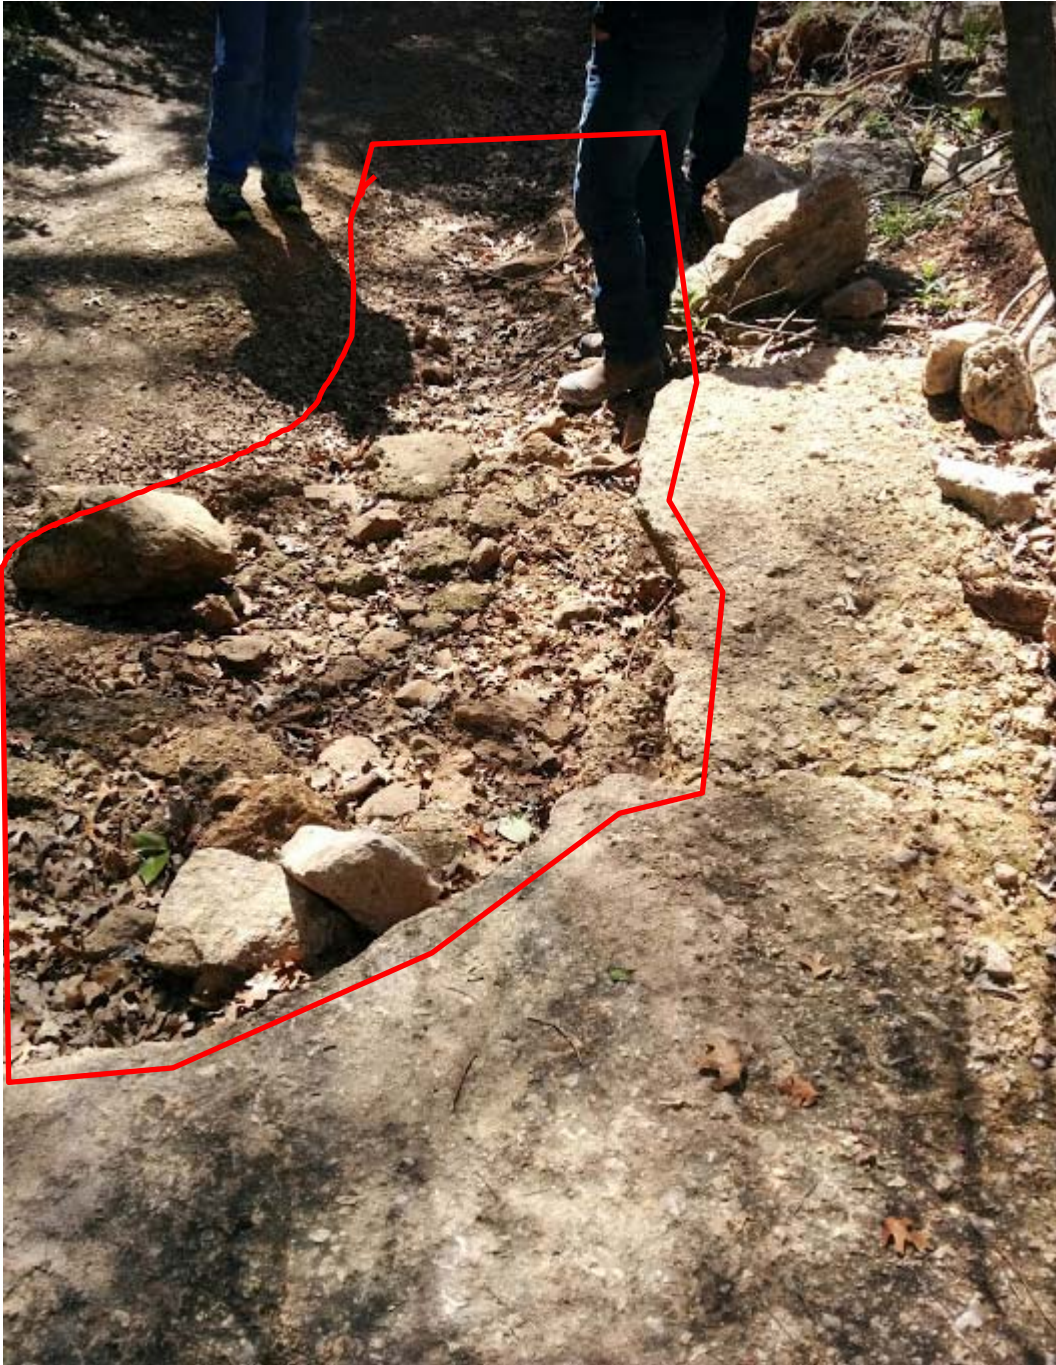
2 – Medium priority - irregular area of trail loss due to ponding water during annual pool emptying and poor drainage across trail to creek. Consider adding a pvc pipe cross drain or leave a low area to allow water to pass to creek.
